Test Report No. 7191151364- MEC17/03 - YX
dated 25 Mar 2017

PERFORMANCE TEST

PARTITION WALL SYSTEM

VODAPRUF VPANEL WALL SYSTEM OF 100MM THK

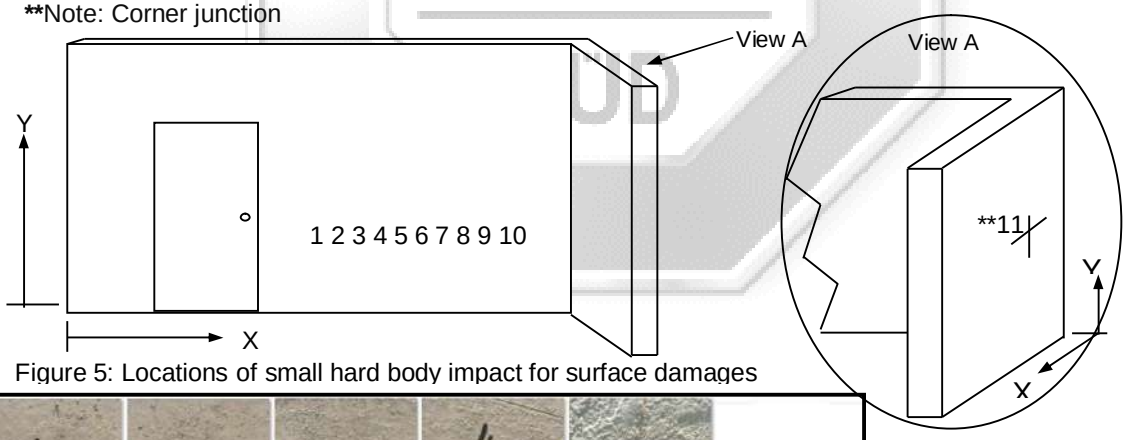
Figure 5: Locations of small hard body impact for surface damages

Impact Position	X (mm)	Y (mm)	Depth of indentation (mm)	Condition of the specimen tested	BS 5234: Pt 2: 1992 or SS 492: 2001 Requirements
1	1910	500	1.6	Tested 1) No detachment, loosening or dislodgement of its parts or fixings occurred. 2) See Fig. 6 photos for closed-up view of surface damage.	1) No specific criterion for acceptance 2) Attached photographs of surface damages for the authority judgement to be made whether can be easily repaired for acceptance
2	2004	500	1.6		
3	2123	500	1.2		
4	2241	500	1.7		
5	2360	500	1.1		
6	2475	500	1.8		
7	2565	500	1.3		
8	2684	500	1.5		
9	2787	500	1.3		
10	2938	500	1.1		
**11	75	608	3.4

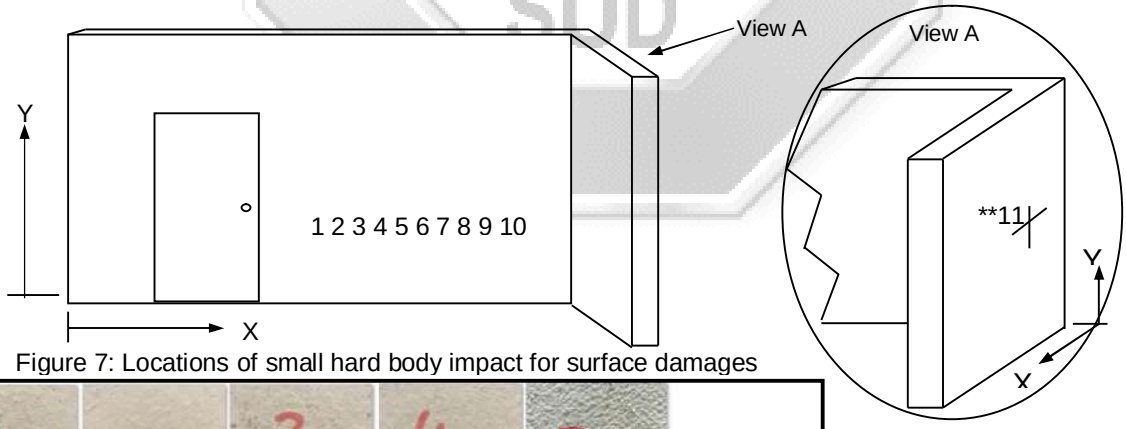
Figure 7: Locations of small hard body impact for surface damages

Impact Position	X (mm)	Y (mm)	Depth of indentation (mm)	Condition of the specimen tested	BS 5234: Pt 2: 1992 or SS 492: 2001 Requirements
1	1921	385	3.4	Passed 1) No perforation of the partition wall was observed 2) See Fig. 8 photos for closed-up view of surface damage.	There shall be no perforation of the partition wall on corner junction, or panel after being subjected to the impact energies.
2	1996	385	3.4		
3	2144	385	3.6		
4	2239	385	3.5		
5	2357	385	2.8		
6	2484	385	2.8		
7	2572	385	2.9		
8	2693	385	3.2		
9	2818	385	2.6		
10	2937	385	2.5		
**11	75	532	5.6

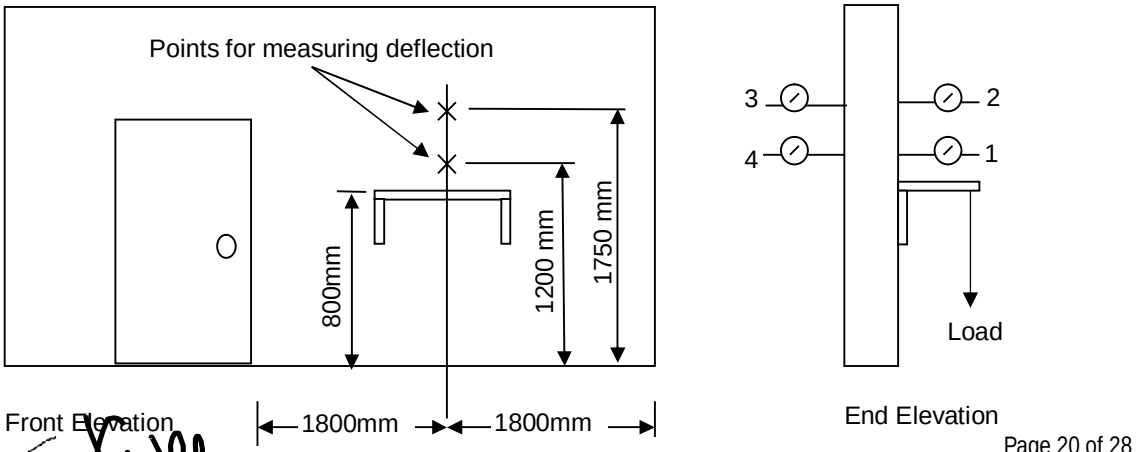
Figure 15: Locations of applied load for heavyweight anchorage (Wash basin) eccentric downward loading test test

Load (N)	Time (min)	Deflection (mm)				Residual deflection (mm)				Condition of the specimen tested
		1	2	3	4	1	2	3	4	
Pretest load of 200	1	0.1	0.1	-0.1	0.1	0.00	0.00	0.00	0.00	
500	1	0.0	0.0	-0.1	0.0	-	-	-	-	
750	1	0.0	0.0	-0.1	0.0	-	-	-	-	
500	1	0.0	0.0	-0.1	-0.1	-	-	-	-	
750	1	0.0	0.0	-0.1	-0.1	-	-	-	-	
500	1	0.0	0.0	-0.1	-0.1	-	-	-	-	Passed*
1000	1	0.0	0.0	-0.1	-0.1	-	-	-	-	
500	1	0.0	0.0	-0.1	-0.1	-	-	-	-	
1000	1	0.0	0.0	-0.1	-0.1	-	-	-	-	
500	1	0.0	0.0	-0.1	-0.1	-	-	-	-	(No damage occurred)
1250	1	0.0	0.0	-0.1	-0.1	-	-	-	-	
500	1	0.0	0.0	-0.1	-0.1	-	-	-	-	
1250	1	0.0	0.0	-0.1	-0.1	-	-	-	-	
500	1	0.0	0.0	-0.1	-0.1	-	-	-	-	
1500	1	0.0	0.0	-0.1	-0.1	-	-	-	-	
500	1	0.0	0.0	-0.1	-0.1	-	-	-	-	
1500	1	0.0	0.0	-0.1	-0.1	-	-	-	-	
500	1	0.0	0.0	-0.1	-0.1	0.0	0.0	-0.1	-0.1

***Note: Shim plate fell off at 1250N. Rectification works was done by reinstalling the wall plugs and the test was conducted again. Results shown above is the 2nd test which was able to meet BS5234/SS492 requirement.**

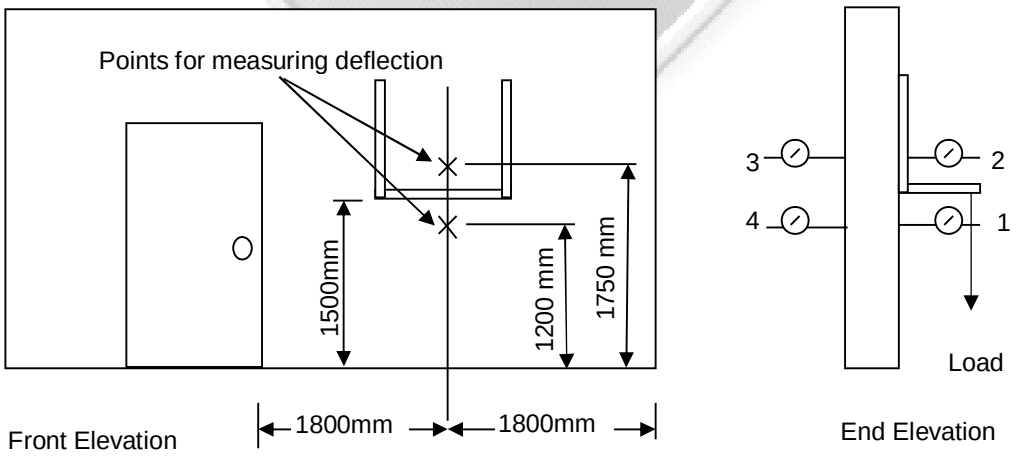
Figure 16: Locations of applied load for heavyweight anchorage
(High level wall cupboard) eccentric downward loading test

Load (N)	Time (Min)	Deflection (mm)				Residual deflection (mm)				Condition of the specimen tested
		1	2	3	4	1	2	3	4	
Pretest load of 200	1	0.0	0.0	0.0	0.0	0.0	0.0	0.0	0.0	Passed* (No damage occurred)
500	1	0.0	0.0	0.0	0.0	-	-	-	-	
1000	1	0.0	0.0	0.0	0.1	-	-	-	-	
1500	1	0.0	0.0	0.0	0.1	-	-	-	-	
2000	1	0.0	0.0	0.0	0.1	-	-	-	-	
2500	1	-0.1	0.0	0.0	0.2	-	-	-	-	
3000	1	-0.1	0.0	0.0	0.2	-	-	-	-	
3500	1	-0.1	0.0	0.0	0.3	-	-	-	-	
4000	1	-0.1	0.0	0.0	0.3	-0.1	-0.1	-0.1	0.0

***Note: Shim plate fell off at 1250N. Rectification works was done by reinstalling the wall plugs and the test was conducted again. Results shown above is the 2nd test which was able to meet BS5234/SS492 requirement.**
